# HYUNDAI – Shaft Collar

November 2006

## Before / After Rust Removal Comparison

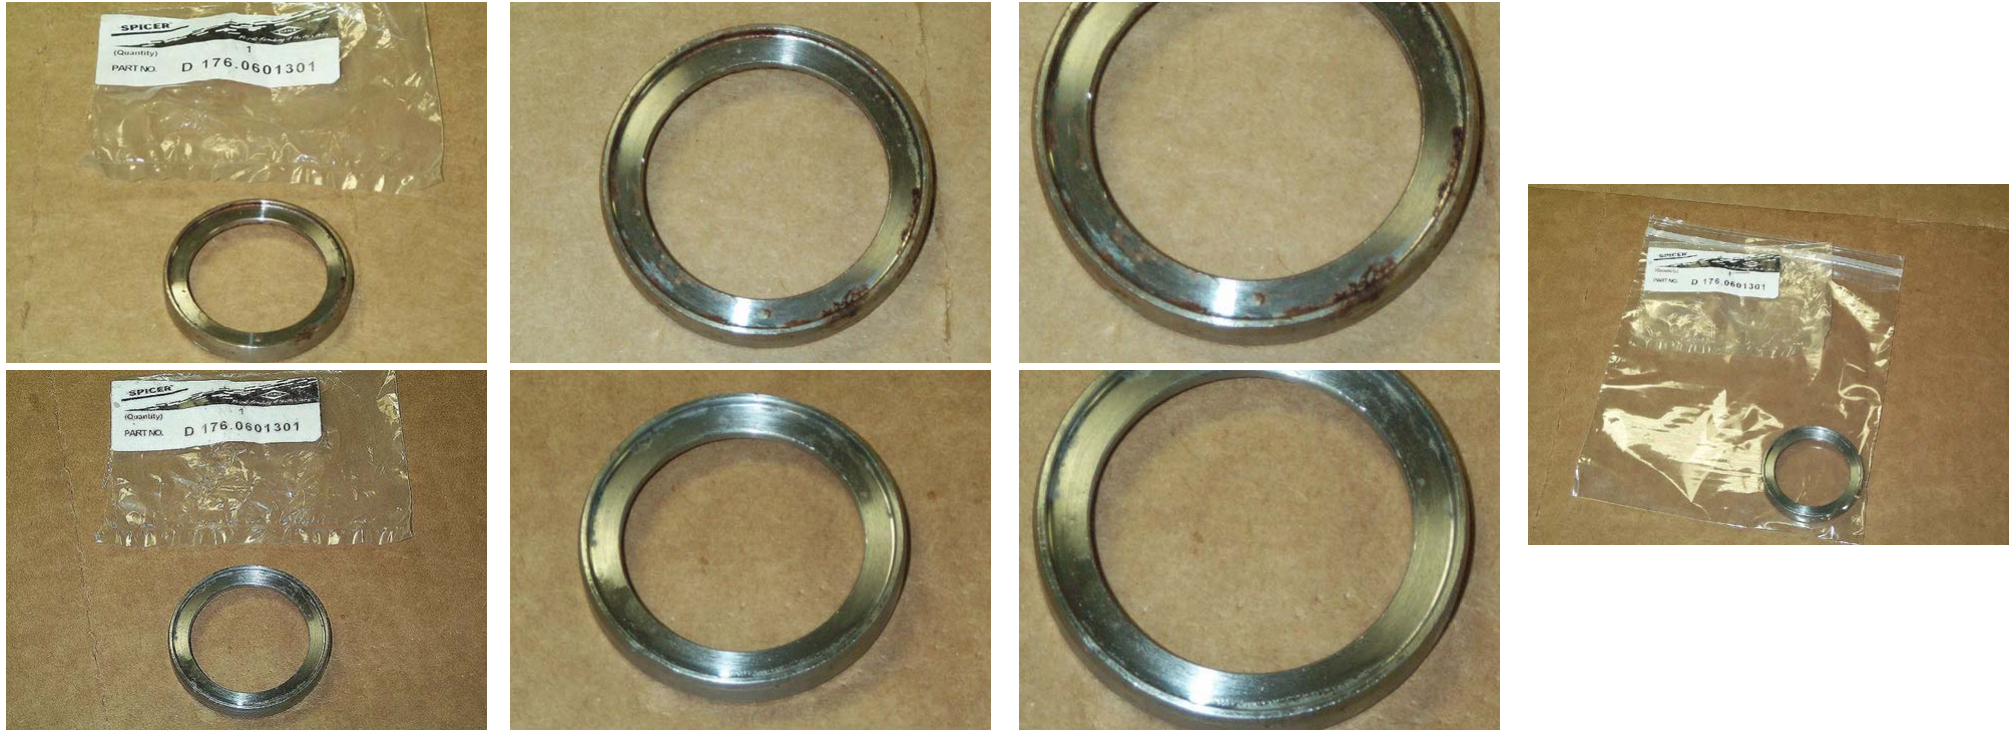
This picture sequence provides detailed before and after rust removal comparisons for a Shaft Collar that was processed at Cetex Industries, during November 2006 using Cetex Industries "Rust Ranger" proprietary "84-4C" Rust Removal Compound by Dip- Soak Method.

The Support was coated with RD – 4100 Light Oil Film Rust Deterrent, and packaged in a polyethylene sealed bag; to provide Rust Deterrence.
