# AGCO – Pivot Boom

June 2006

Target And Remove Rust

6 – 712 - 64

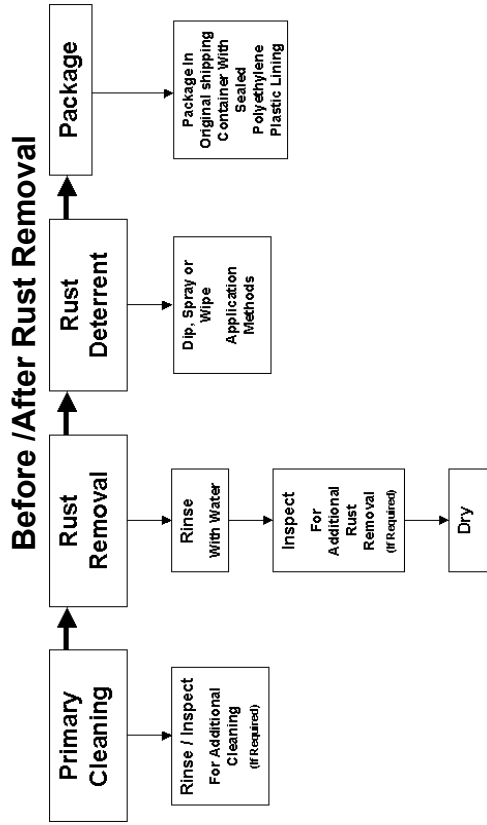
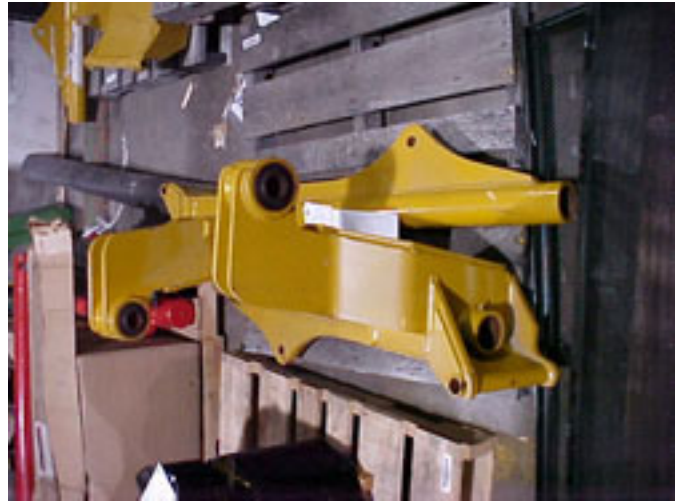
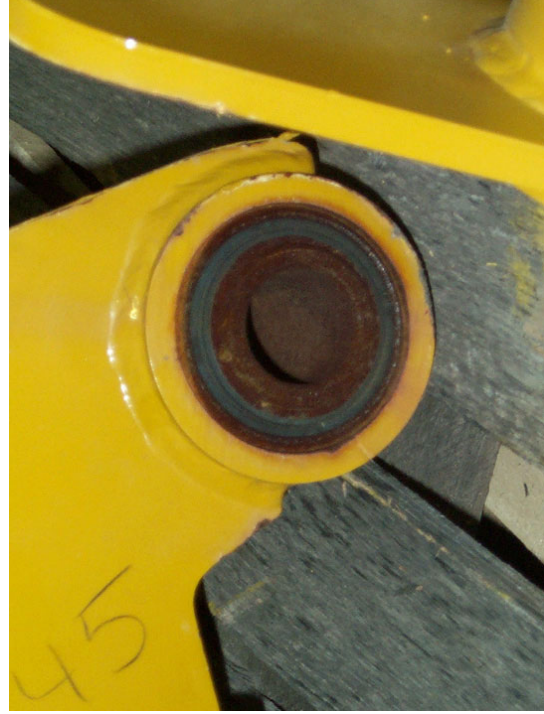
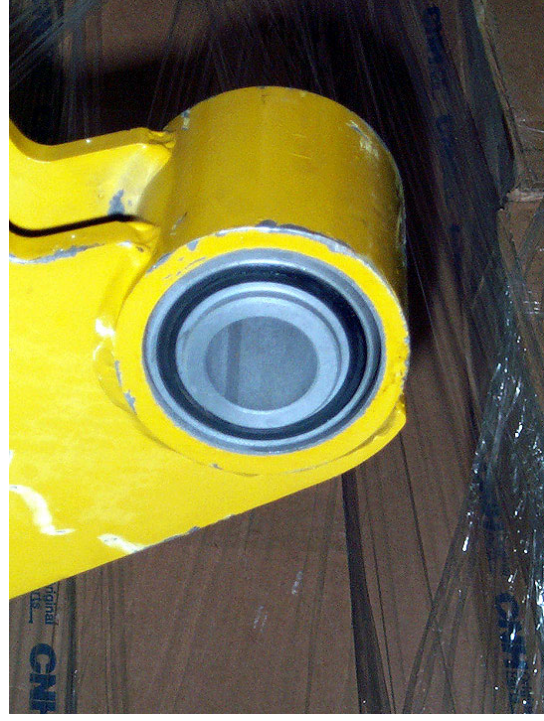
This picture sequence provides detailed before and after rust removal comparisons for Pivot Booms; that were processed at Cetex Industries, during June 2005; using Cetex Industries “Rust Ranger” proprietary “84-4C” Rust Removal Compound with Cetex Industries proprietary processes and processing equipment.

The part was not taken apart during processing, and did not require specific special handling requirements; and was processed by Dip-Soak Method.

After processing items was coated inside and out with RD – 4000 Dry Film Rust Deterrent.
