CNH – Skid Steer Housing

June 2003

Target And Remove Rust

Before / After Rust Removal Comparison

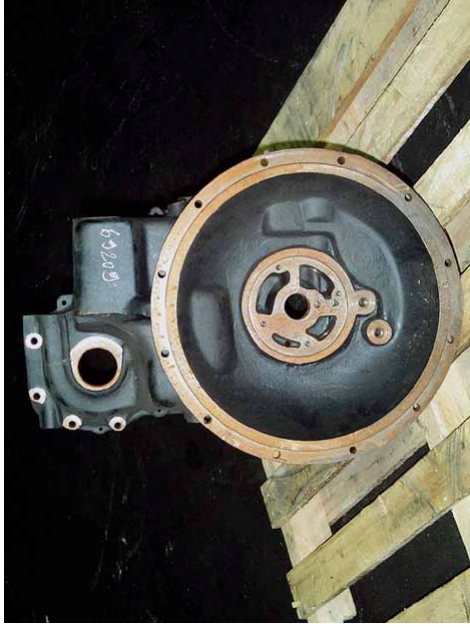
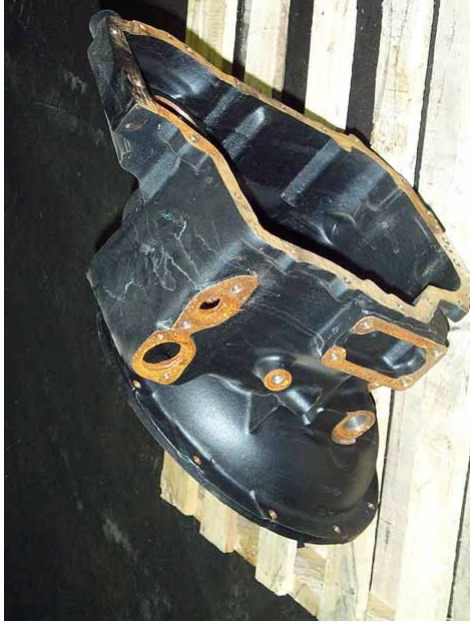
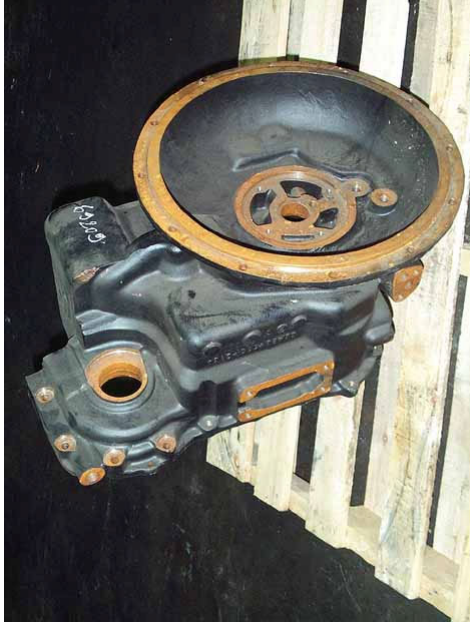
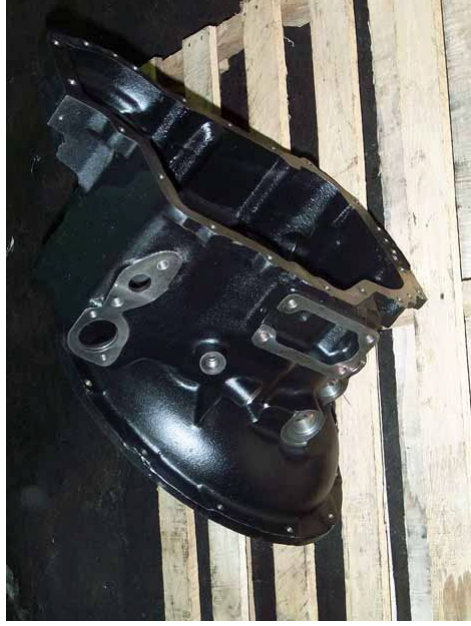
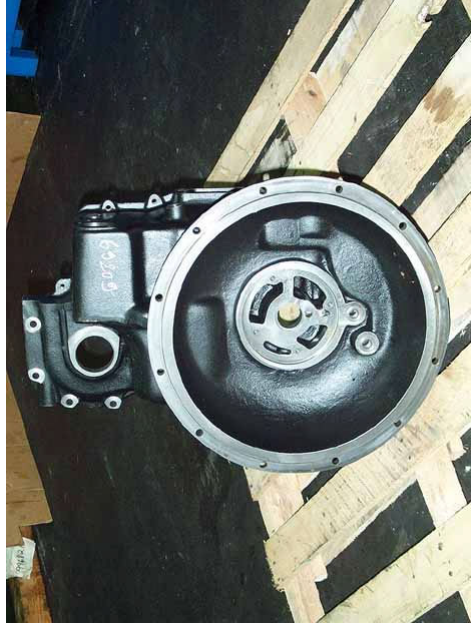
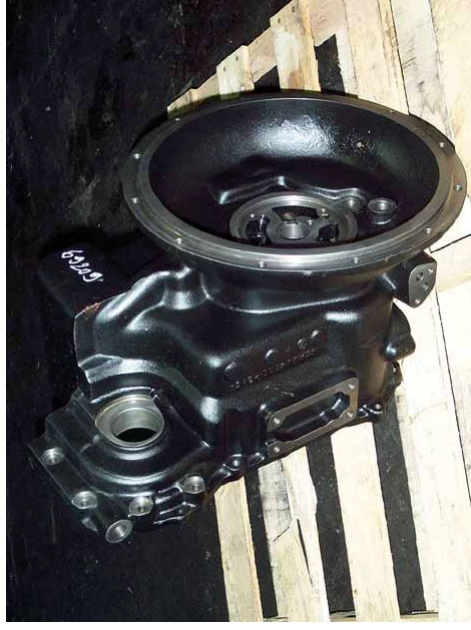
This picture sequence provides detailed before and after rust removal comparisons for a Skid Steer Housing that was processed at Cetex Industries, during June 2003; using Cetex Industries “Rust Ranger” proprietary “84-4C” Rust Removal Compound by Dip- Soak Method.

The Housing was coated with RD – 4100 Light Oil Film Rust Deterrent, to provide Rust Deterrence.
