# Twin Disc - Clutch Spindle

March 2007

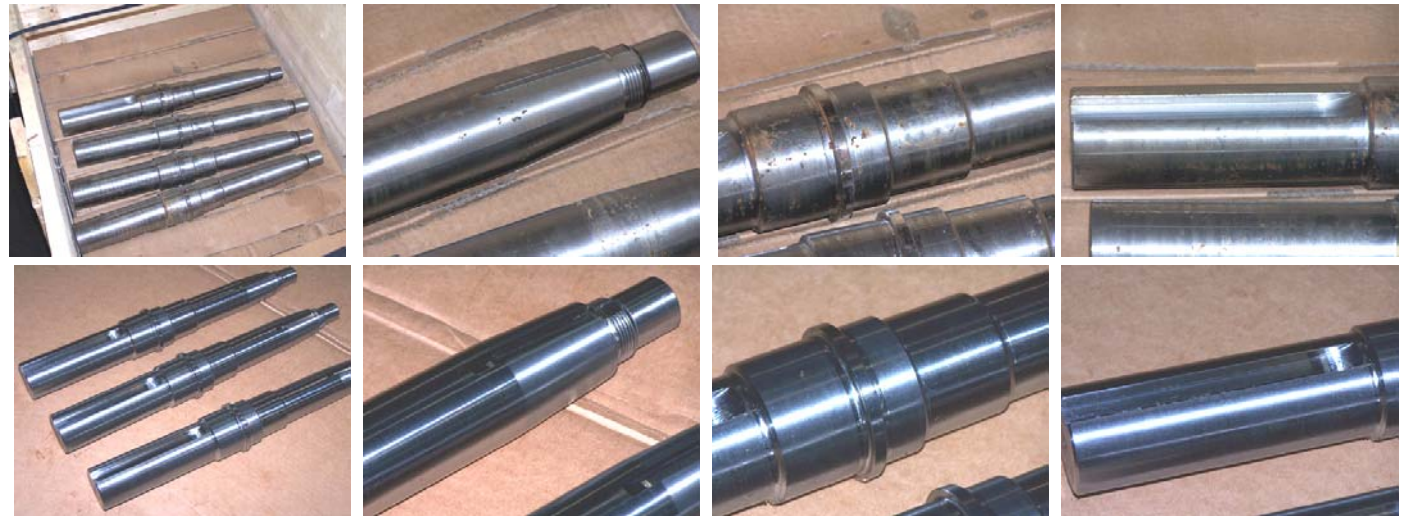
Before /After Rust Removal

This picture sequence provides detailed before and after rust removal comparisons and process sequence for lot quantity of Twin Disc, Clutch Spindles. The Clutch Spindles were processed at Cetex Industries, during February – March 2007 using Cetex Industries “Rust Ranger” proprietary “84-4C” Rust Removal Compound with Cetex Industries proprietary processes and processing equipment.

These Clutch Spindles did not require special handling requirements, and were processed by Dip-Soak Method.

After processing Clutch Spindles were coated with RD – 4100 Light Oil Film Rust Deterrent; to provide Rust Deterrence
