**Deere-Hitachi
Sprocket (#AT218227 and # P64306)**

March 2004

Target And Remove Rust

Before / After Rust Removal Comparison

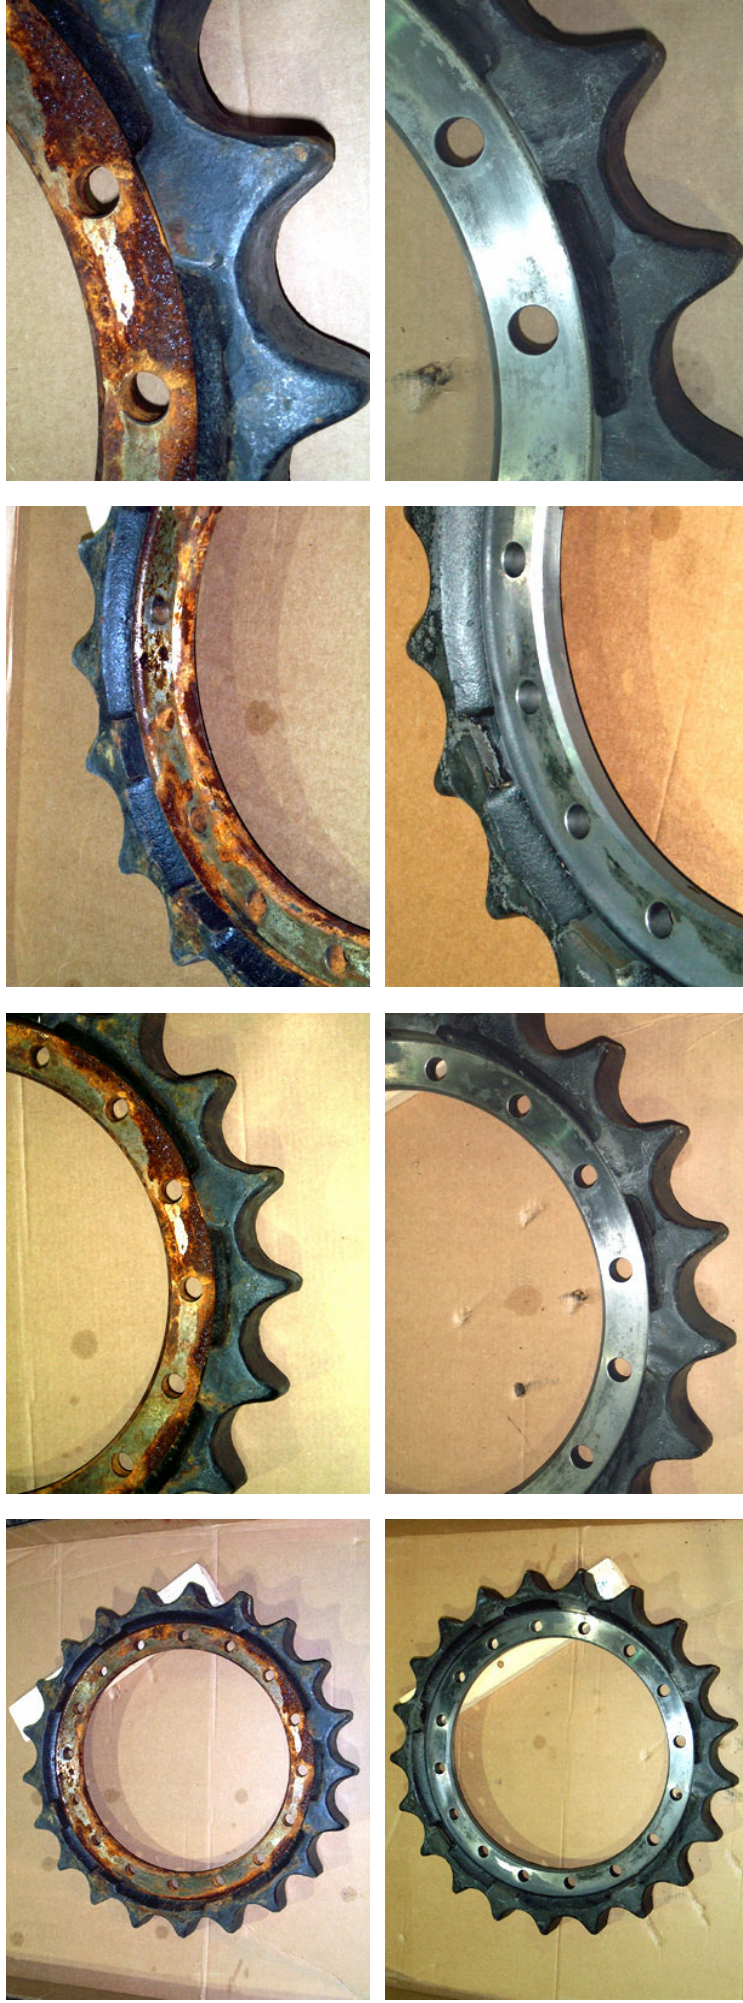
This picture sequence provides detailed before and after rust removal comparisons for a Lot Quantity of Sprockets that were processed at Cetex Industries, during March 2004 using Cetex Industries "Rust Ranger" proprietary "84-4C" Rust Removal Compound. The parts were processed by Dip- Soak Method, and did not require any special handling.

The Sprockets were coated with RD – 4100 Light Oil Film Rust Deterrent; to provide Rust Deterrence.
