Mitsubishi Caterpillar Forklift America

## Front Axle – Forklift

Target And Remove Rust  
1175-109 - 5

### Before /After Rust Removal

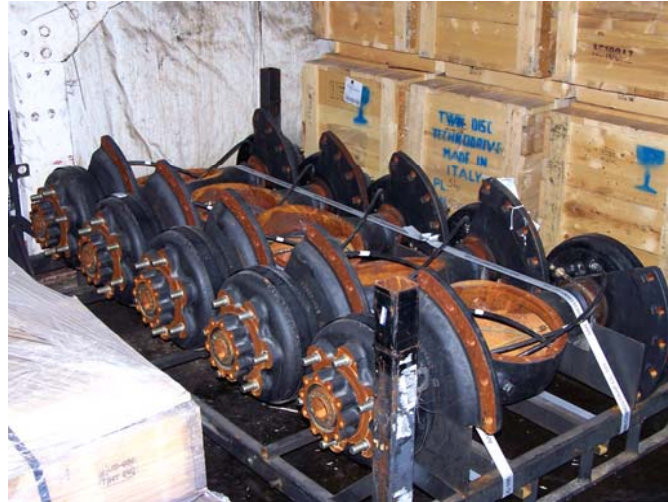
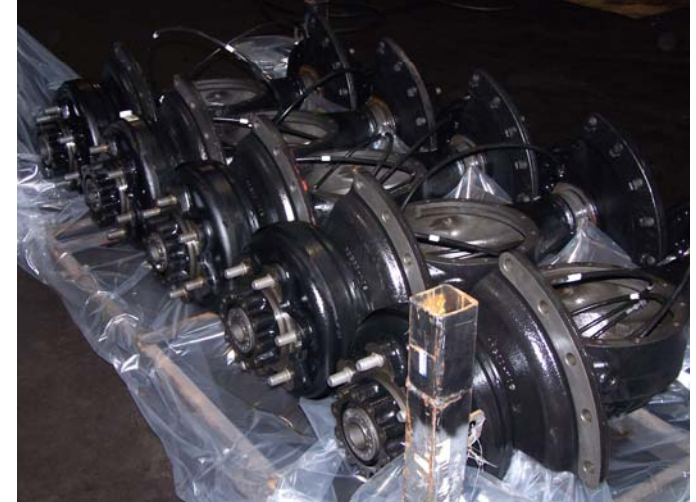
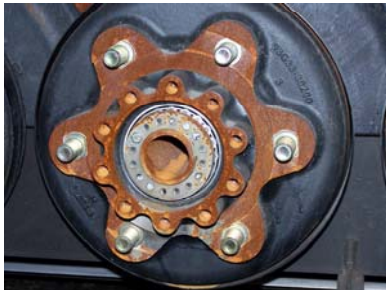
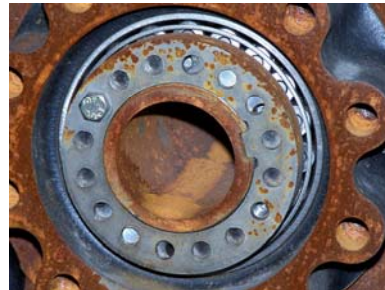
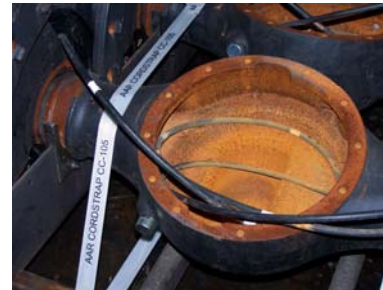
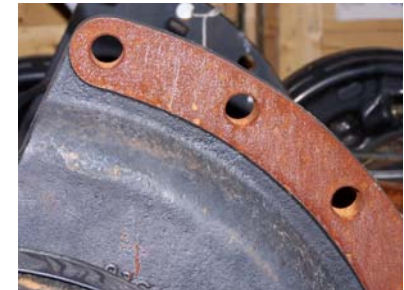
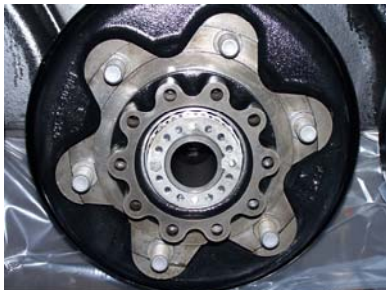
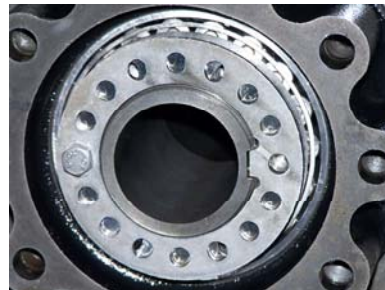
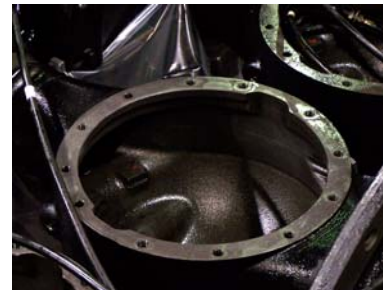
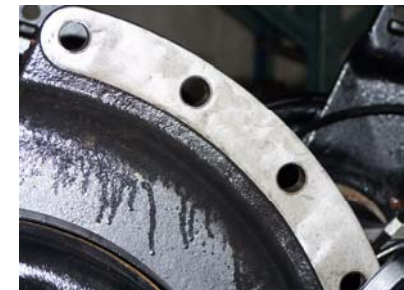
This picture sequence provides detailed before and after rust removal comparisons for a series Forklift Front Axle that were processed at Cetex Industries, during February 2007 using Cetex Industries "Rust Ranger" proprietary "84-4C" Rust Removal Compound with Cetex Industries proprietary processes and processing equipment.

These Axles weigh 298 Lbs / Each

The Axles was processed using Cetex's Dip-Soak Removal Method.

After processing Axles were coated with RD - 4100 Light Oil Film Rust Deterrent; to provide Rust Deterrence
