AGCO – Housing AS

Steel / Rubber Insert Composite Housing

December 2006

Target And Remove Rust

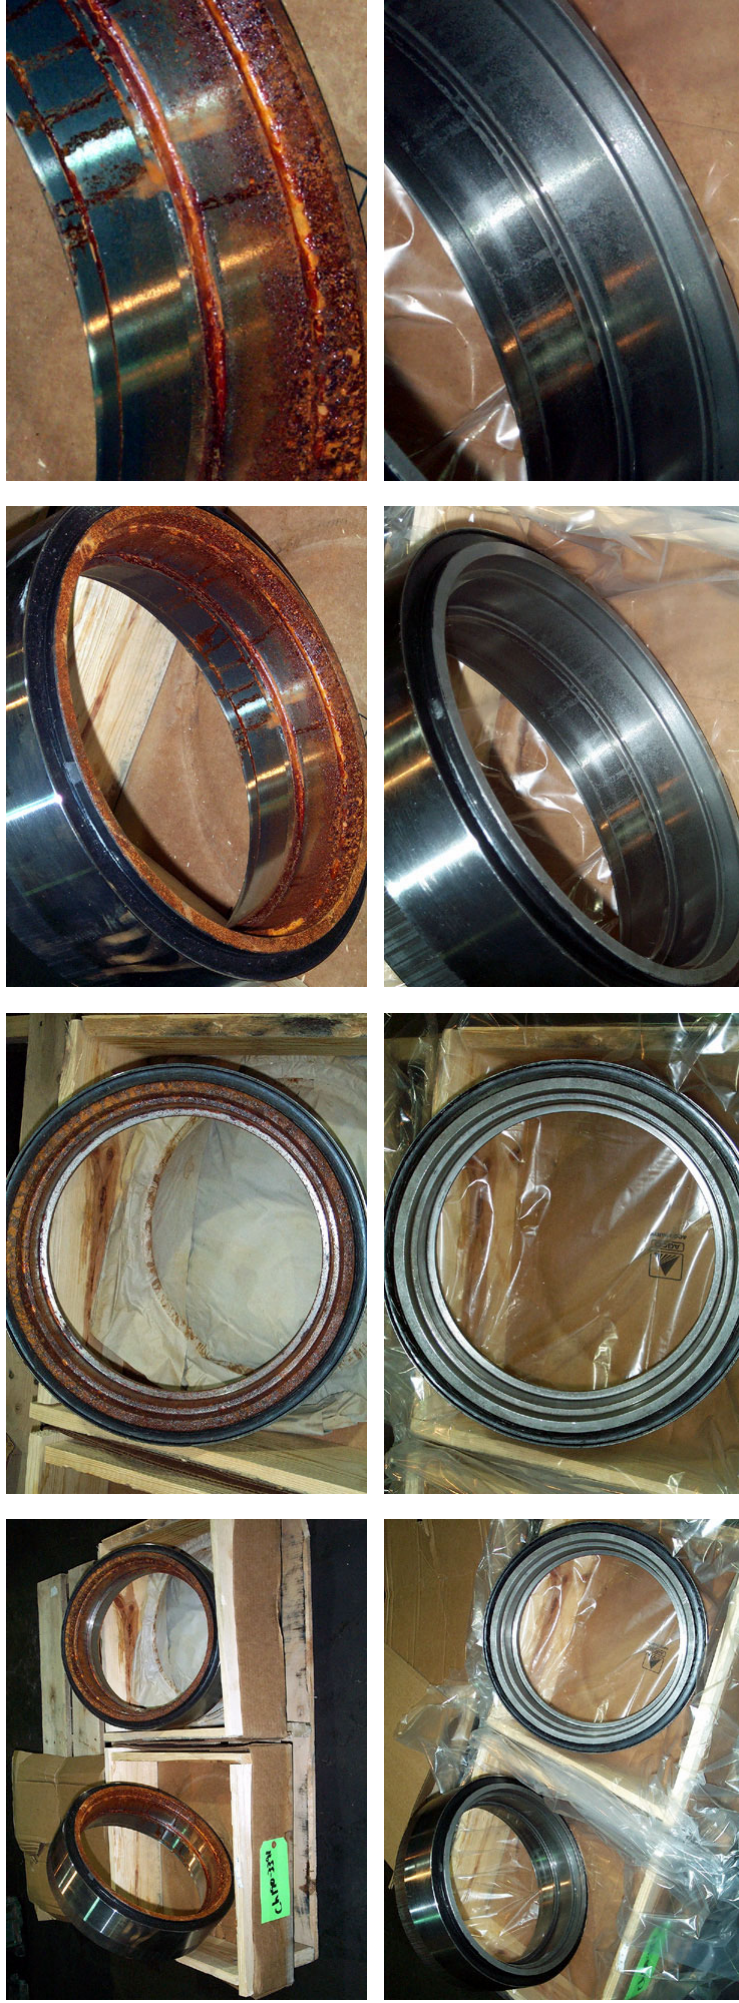
Before / After Rust Removal Comparison

This picture sequence provides detailed before and after rust removal comparisons for a Lot Quantity of AS Housings that were processed at Cetex Industries, during March 2004 using Cetex Industries “Rust Ranger” proprietary “84-4C” Rust Removal Compound. The parts were processed by Dip- Soak Method, and did not require any special handling.

The AS Housings were coated with RD – 4100 Light Oil Film Rust Deterrent; to provide Rust Deterrence.
